# AIR SERVICE INFORMATION CIRCULAR

No. 365

## STATIC TEST OF THE AEROMARINE PG-1 AIRPLANE

Prepared by E. R. Weaver  
Engineering Division, Air Service  
McCook Field, Dayton, Ohio  
April 20, 1922

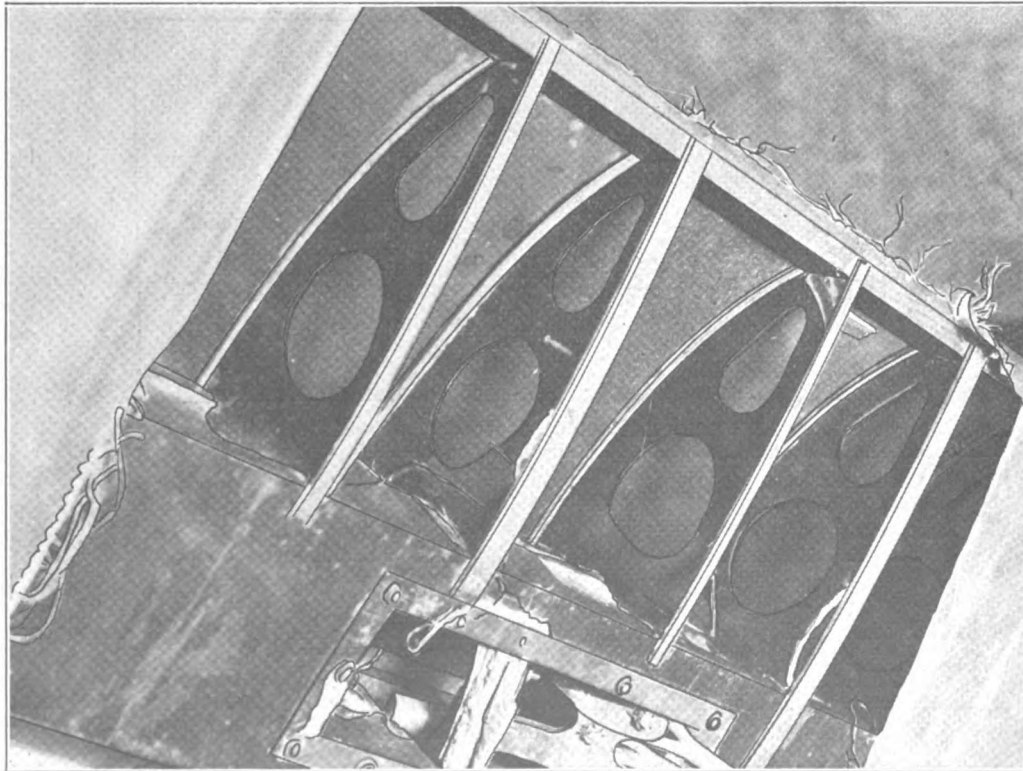
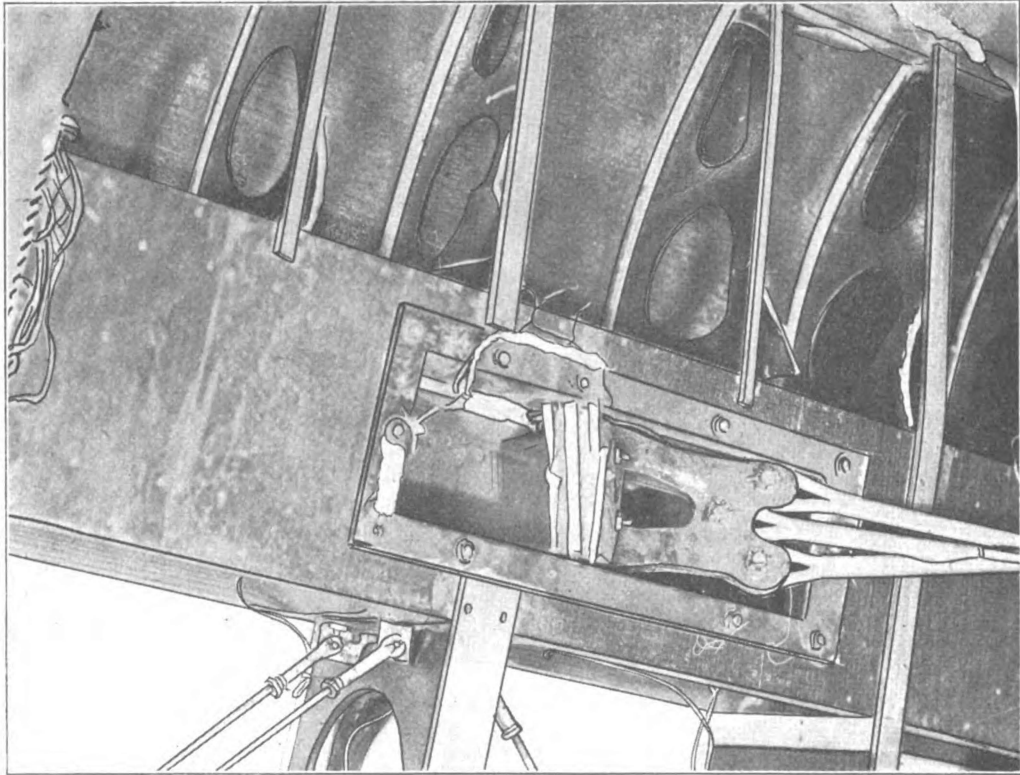
Figures 32 and 33 are photographs of the right upper front spar fitting and spar failures.

The load factor required is 7. At a load factor of 5 the compression tube in the center section of the upper front spar deflected severely and had to be braced before the test could be continued.

The right upper front strut fitting failed in bending while the structure was supporting a load factor of 6.5.

The upper front spar fittings are too weak to support the required load. The front spar compression tube in the center section should be heavier.

FIG. 32.—Spar and compression tube failure.

FIG. 33.—Spar and compression tube failure.

Redesign strut fitting.

Redesign upper front spar compression tube to prevent severe deflection.

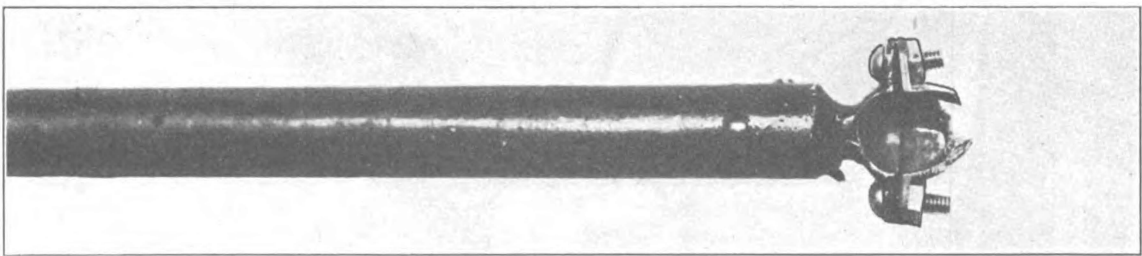
*First test.*—At a load of 15 pounds per square foot the control stick deflected badly. The corresponding pull on the stick was 90 pounds. At a load of 20 pounds per square foot the ball joint on the end of the link connecting the control stick with the remainder of the control mechanism failed. Considerable crackling of the wing structure was noticed while the aileron was being tested.

Figure 34 is a photograph of the ball joint failure.

FIG. 34.—Ball joint failure

Redesign the aileron control system and the mounting of the bell crank in the wing structure so that the control system will stand a load of 25 pounds per square foot without failure.

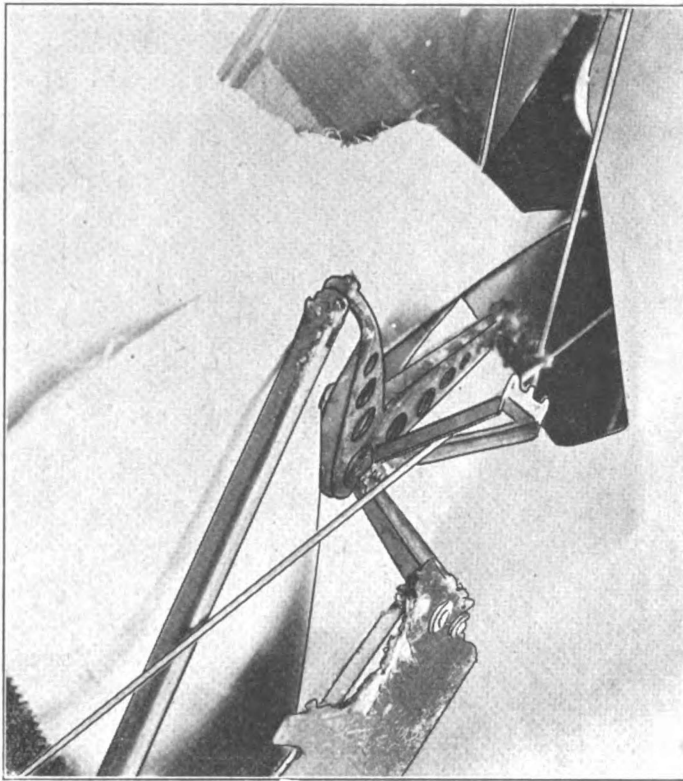
crank, which is mounted in the wing structure, failed by twisting. The aileron structure showed no signs of failure.

Figure 35 is a photograph of the bell crank failure.

While no weakness was manifest in the aileron structure during the test, the aileron controls failed before the required load was applied to the surface of the aileron, the required load being 25 pounds per square foot.

FIG. 35.—Ball crank failure.

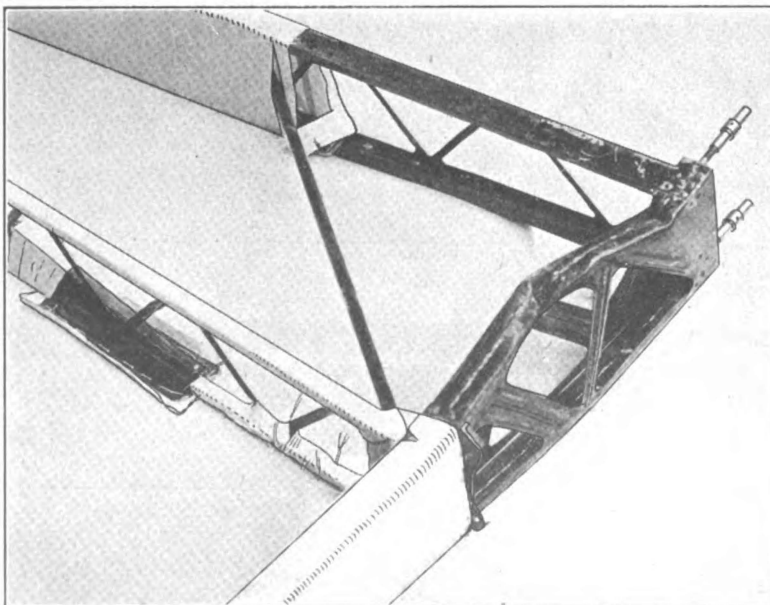
The first failure was the buckling of the rear spar of the stabilizer at a load of 20 pounds per square foot. The right side collapsed. The test was continued on the left side of stabilizer and at 27.5 pounds per square foot failure occurred.

First failure at loading of 20 pounds per square foot right rear stabilizer spar buckled between first and second rib from fuselage.

Figure 36 is a photograph of the failure of the right side of the stabilizer spar.

FIG. 36.—Failure of right stabilizer spar.

Redesign stabilizer rear spar to eliminate failure in bending.

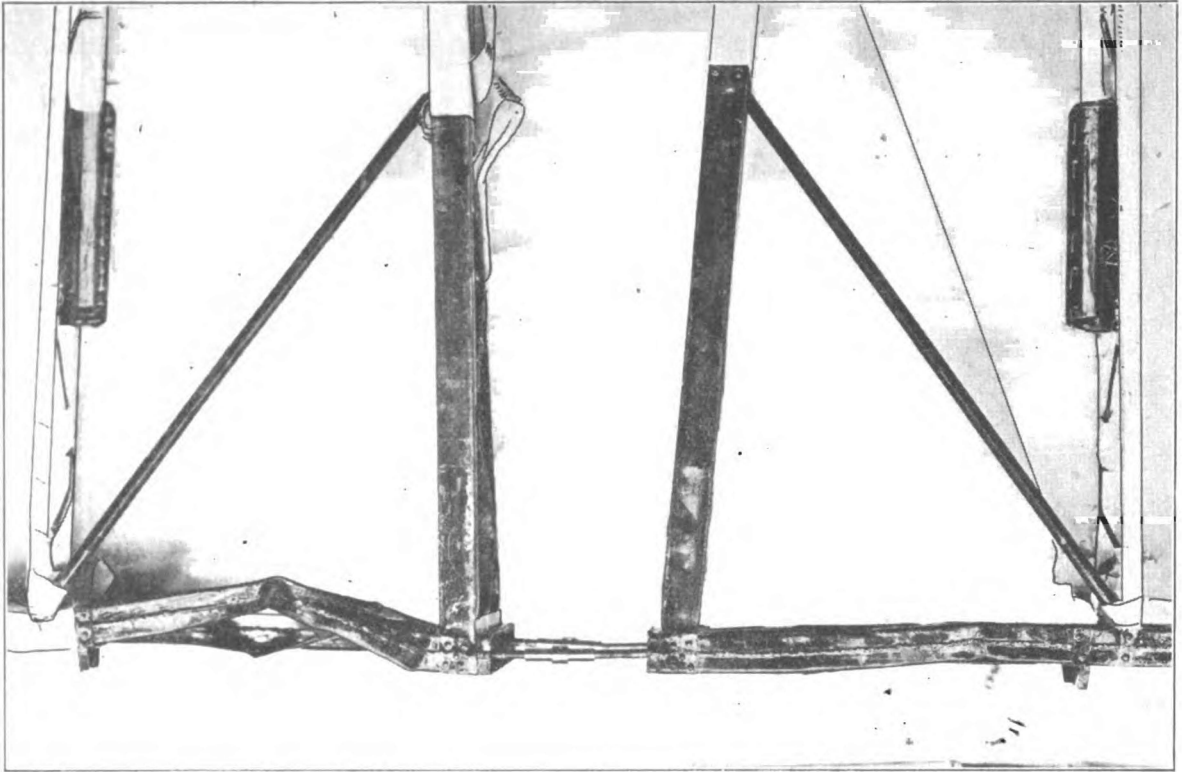
Second failure at loading of 27.5 pounds per square foot left rear stabilizer spar.

Figure 37 is a photograph of both right and left spar failures.

FIG. 37.—Failure of right and left stabilizer spars.

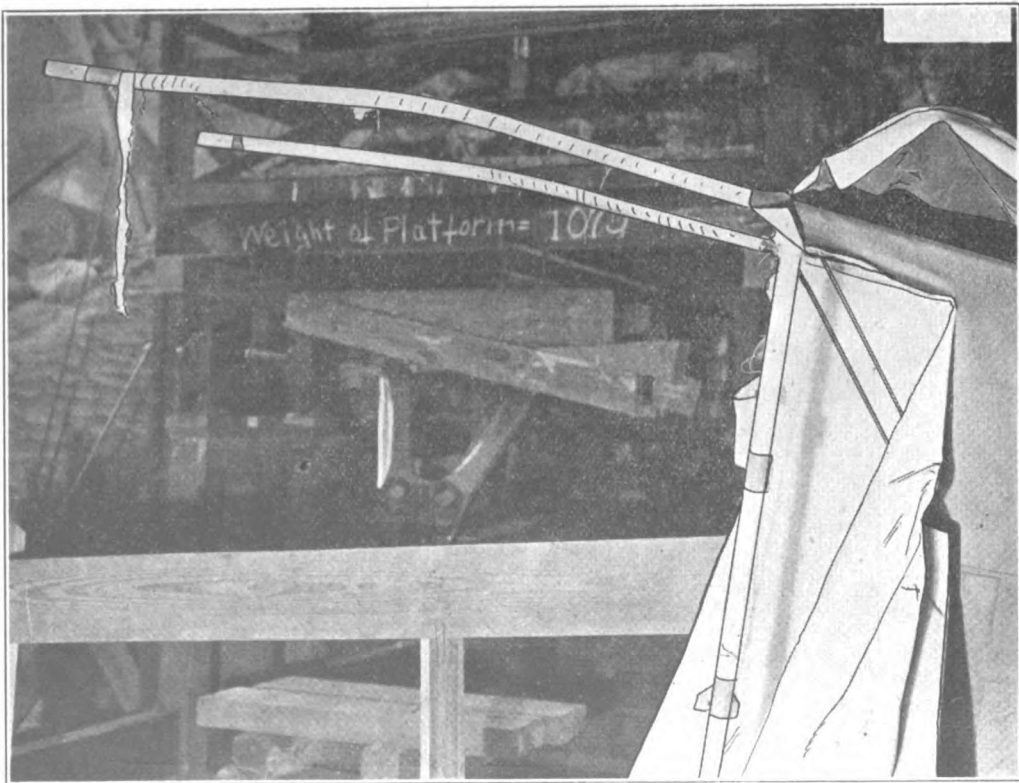
The deflections and results are shown in Figure 29. The required load factor was 6. The structure supported a load factor of 6.5 and then failed in first bay to rear of the armor plate. The lower longerons failed in compression.

The first failure was the left lower longeron, which failed when the fabric was cut. The tube was drawn back to place by blocks and clamps and a load factor of 7 was imposed. The fabric on the right side was then cut and failure of right longeron followed.

Figure 38 is a photograph of lower longeron failures.

FIG. 38.—Lower longeron failure.

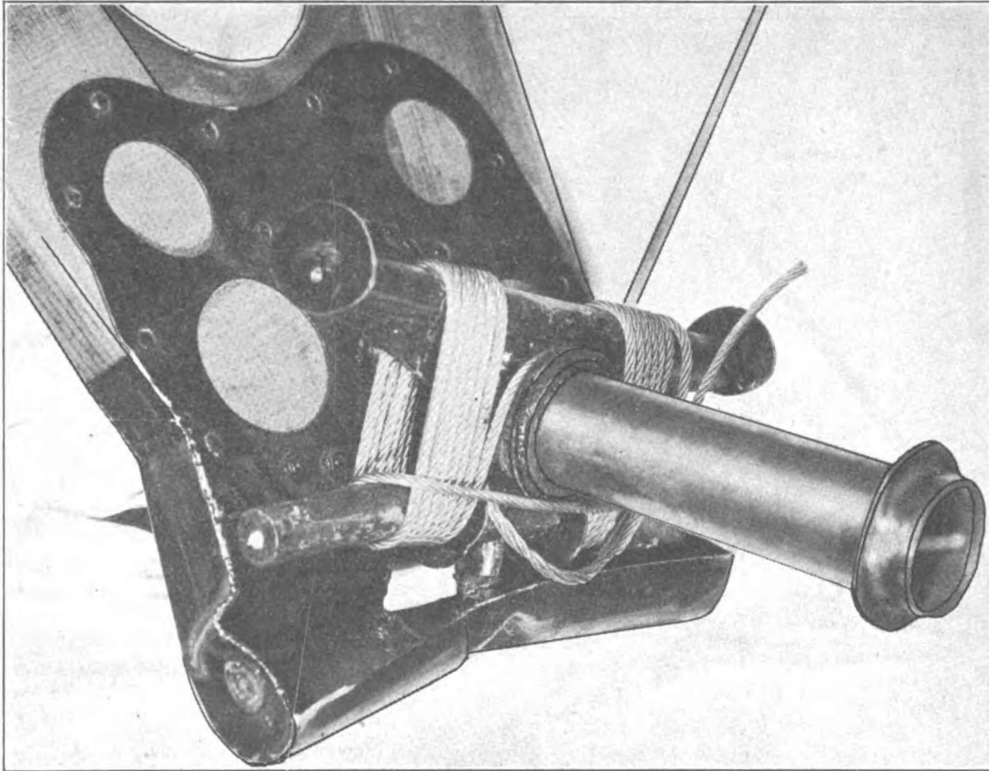
Load carried to a factor of 5 for one minute when the right shock absorber fitting failed. The two five-sixteenths-inch cap screws at the ends of the shock-absorber fitting failed by shearing, while the center three-eighths inch screws pulled through the lower part of the fitting. The struts and axle withstood loading.

The right shock absorber fitting failed at a load factor of 5. The two five-sixteenths bolts sheared off while the center three-eighths inch bolt on the lower side pulled entirely through the fitting.

Figure 39 is a photograph of the failure.

FIG. 39.—Landing gear failure.

Strengthen the shock-absorber fittings where failures occurred. These fittings should be redesigned to stand a load factor of 6, the required factor for the struts.

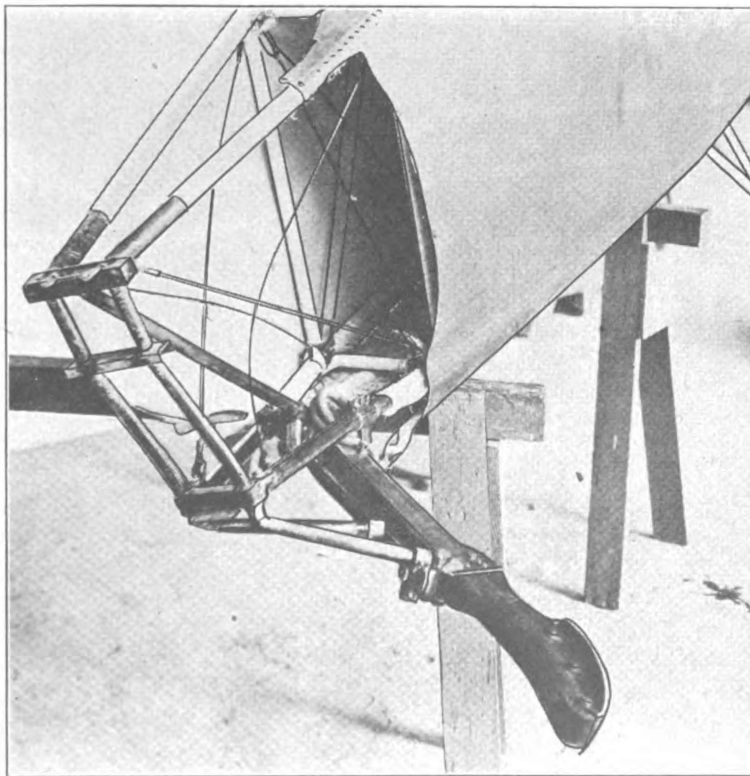
On the 18-inch drop one small crack was noticed on the tail skid and the fuselage twisted somewhat.

Figure 40 is a photograph of the failure.

The required distance a tail skid must be able to drop without failure is 36 inches.

FIG. 40.—Tail skid failure.

Redesign tail skid, shock absorber, and rear of fuselage to withstand a 36-inch drop.
